LEVEL 2

Your survey report...

Surveyor's RICS number
0980814

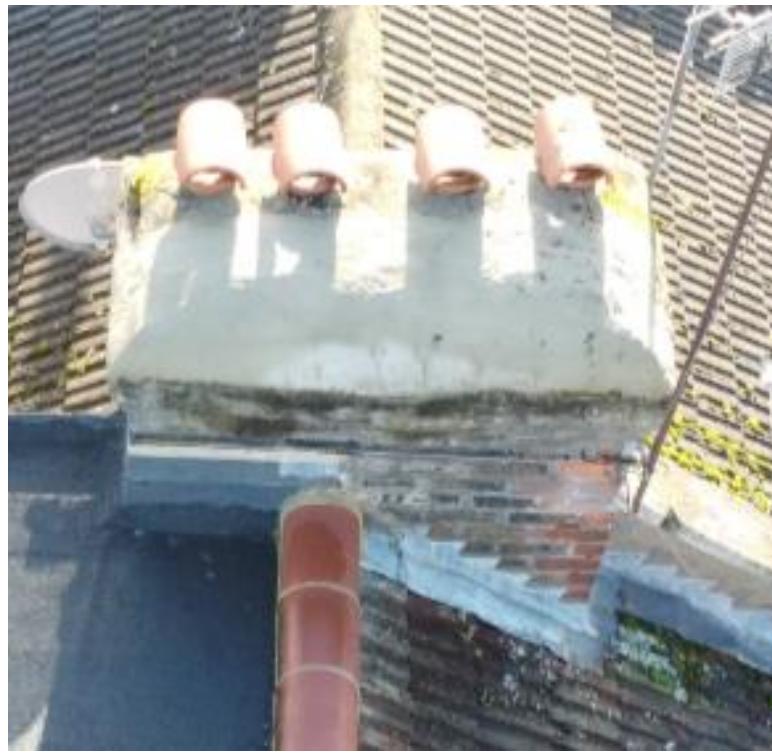
Chimney stack

The chimney stack is displaying signs of weathering, but no repairs are required at this time.

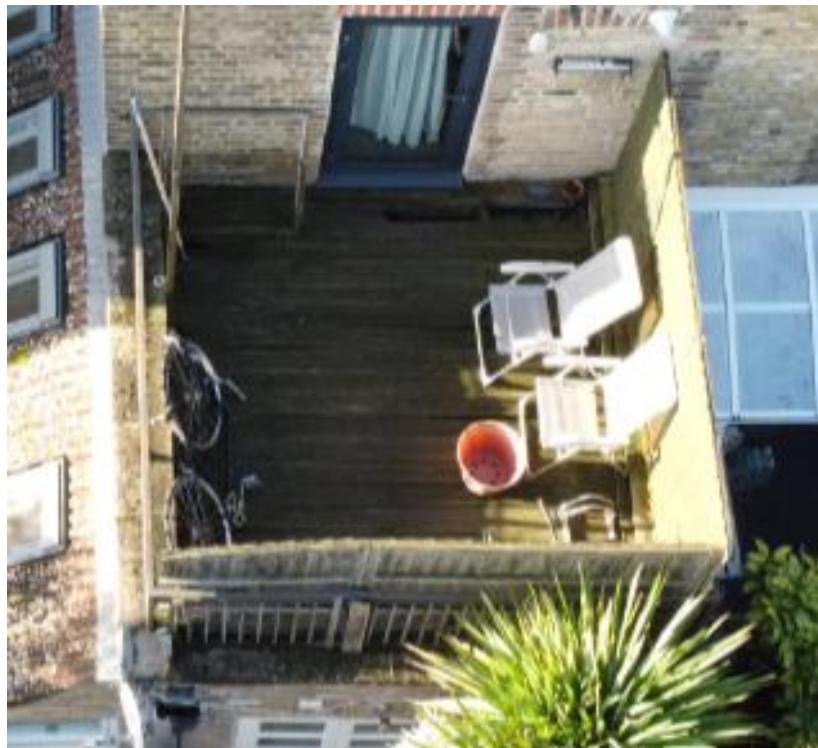
Rear extension roof/terrace

The rear extension roof is flat and currently functioning as a roof terrace for the property above. The underlying roof structure is formed from traditional timber rafters. A roof structure of this construction is cut and built on site. The roof covering is not visible due to the timber decking surface finish. The roof surface will be susceptible to damage and wear, with leaks to the roof

Flat roofs are susceptible to sudden leakage, especially at the joints/seals. Although no such defects were noted at the time of inspection.

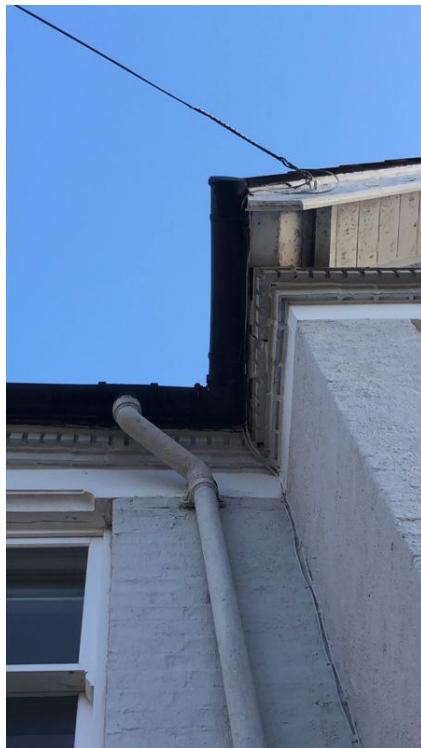
- Deterioration was noted to the joints of the gutters and downpipes. Leaking rainwater systems can cause dampness to the interior of the building and damage to the fabric, including wet and dry rot. You are advised to make repairs at the earliest opportunity and to keep gutters and downpipes clear.
- Vegetation was noted in the front gutter. This can prevent rainwater from discharging adequately and cause rainwater to overflow the gutters.

Deterioration was noted to the joints of the gutters and downpipes

Repair or replace the gutter and downpipes as required. When the repairs are undertaken, the falls to the gutters should be checked to ensure the water runs to the fall pipes.

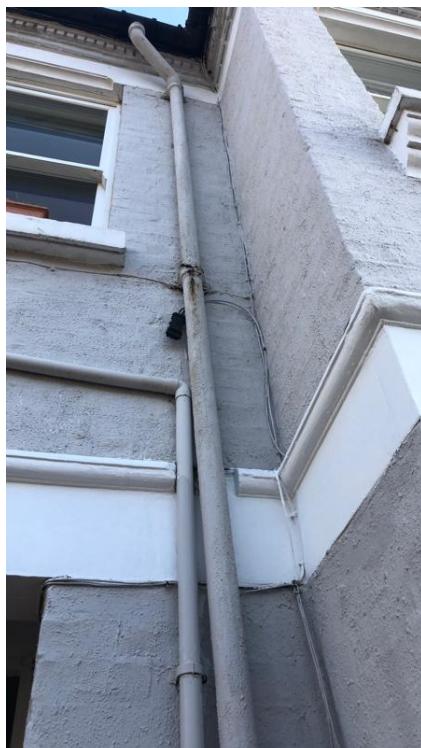
Deterioration was noted to the joints of the gutters and downpipes

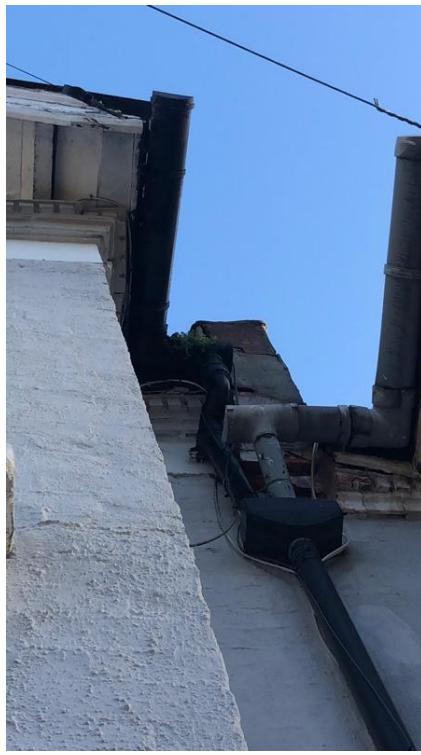
Vegetation was noted in the front gutter

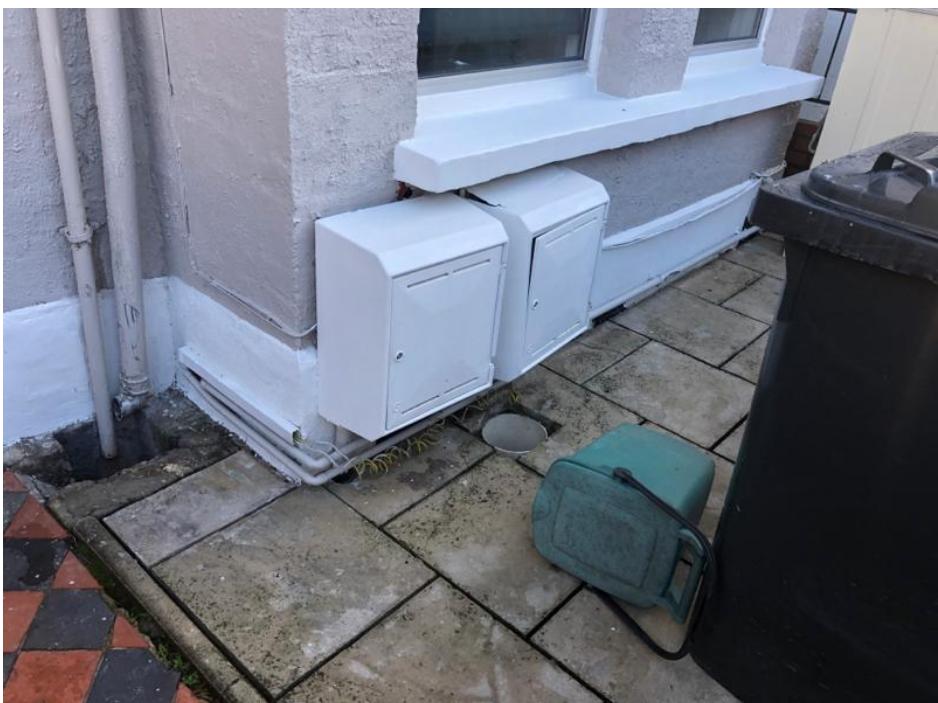
- No Damp Proof Course (DPC) was visible at the time of inspection. This is because a render upstand has been applied to the base of the walls. This is contrary to good construction methods, and it could cause bridging of the DPC, resulting in damp to the interior and possible timber decay to floor timbers and spoiled decorations to the interior. In addition, high moisture meter readings were noted to the internal face of the wall (refer to section E3).

Render upstand to base of wall

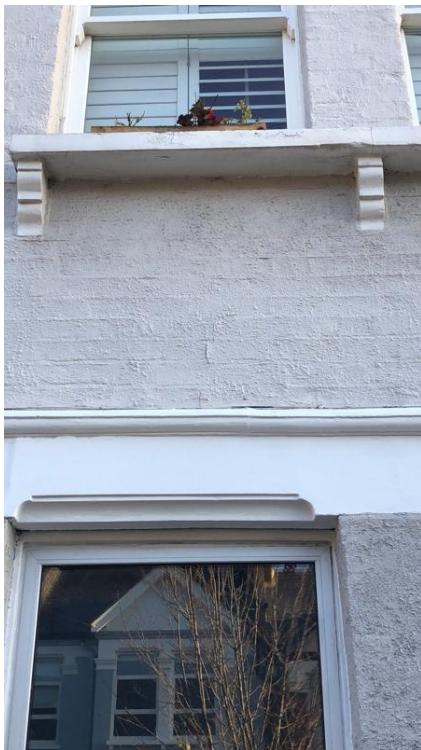
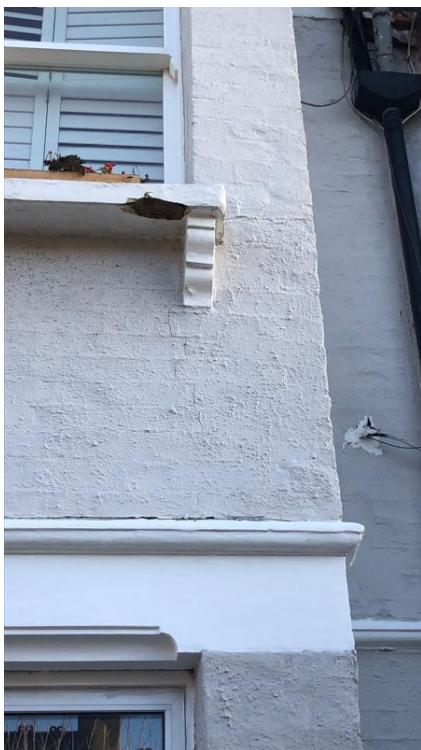
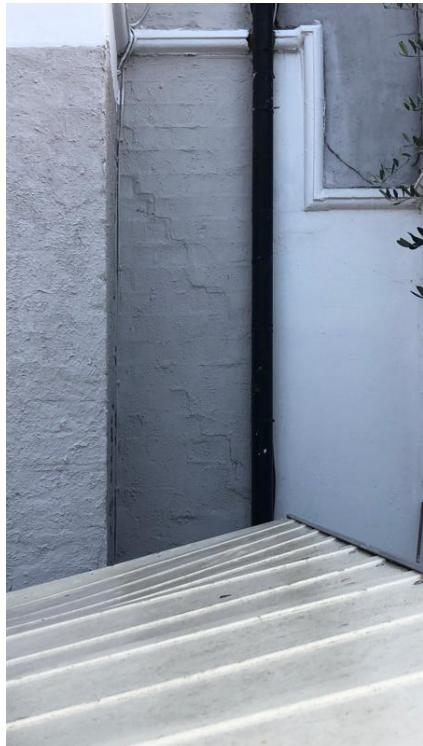
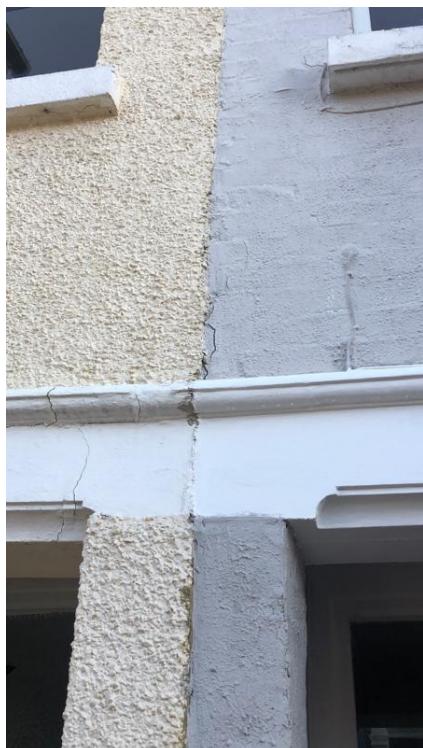
- Settlement cracking was noted to the front elevation. This is an indication that the property has been affected by movement. At the time of inspection, the movement appeared to be historic. However, some further movement may happen going forward in prolonged wet or dry spells, depending upon the ground sub-soil type.

Settlement cracking was noted to the front elevation

Repair the settlement cracking as required. The external walls should be monitored moving forward, and if any further movement is identified, then you are advised to instruct a Structural Engineer to prepare a report on the causes and recommended remediation work, together with a cost estimate. If there is an existing building insurance cover, the policy should be consulted to see if the costs can be recovered in part or entirely. In the extreme, some complete rebuilding of existing parts may be required.

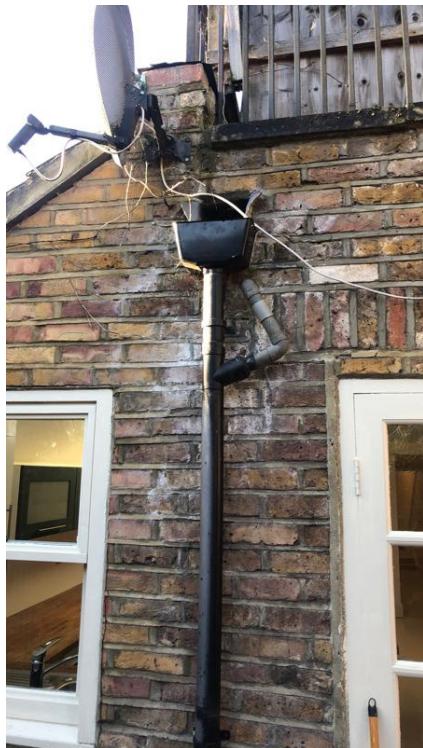
- Efflorescence was noted on the rear elevation. Efflorescence is the deposit of salts as a crystalline deposit on the surface of walls caused by evaporation of the water in which the salts were dissolved. Although this can be unsightly, it causes no harm to the walls and can be brushed off as and when required. Initially, in new building work, it may appear quite quickly and require frequent brushing off. It will eventually stop as the contained salts are dissipated.

Efflorescence was noted to the rear elevation

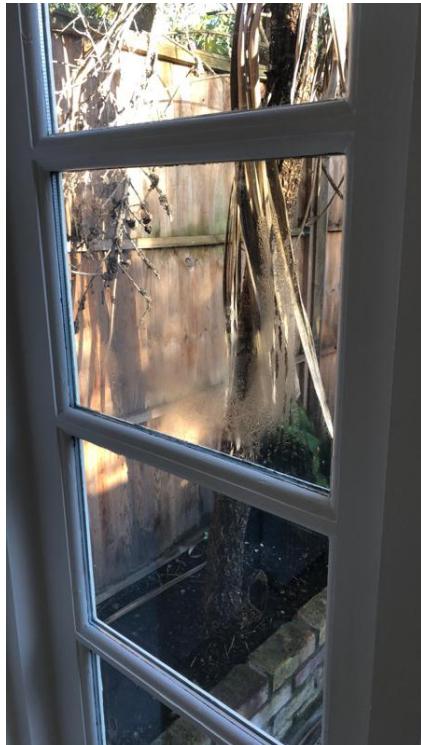
units are no longer sealed, and this causes misting on the inside of the glass cavity. The double-glazed units need to be replaced where this has happened. When this happens, particularly with older fittings, it is not unusual for other sealed units to fail over time.

A failed glazing unit was noted to the rear window

Replace any failed glazing units as required.

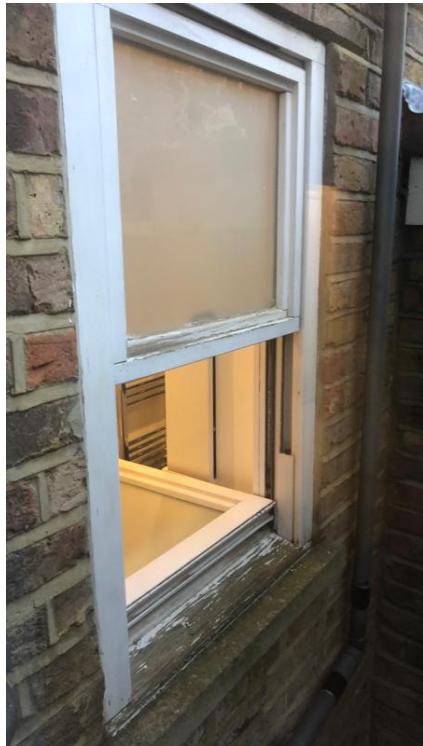
- Weathering was noted to the bathroom window and window frame.

Weathering was noted to the bathroom window and window frame

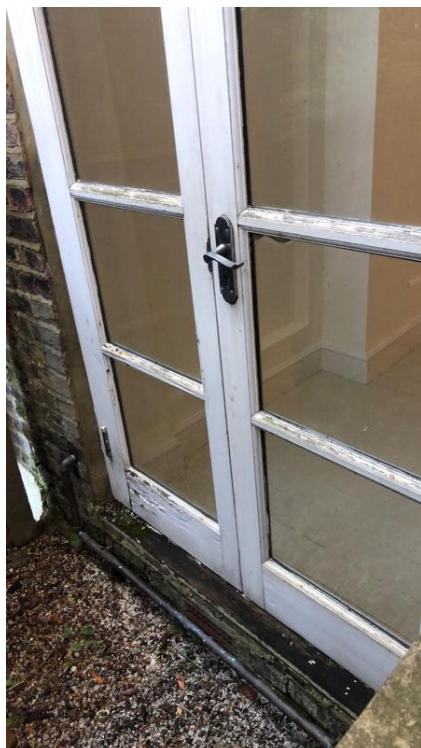
- We could not find any British Standard Safety Marks on the glazed elements, and we assume that the glass is not "Safety Glass". We recommend that the glass be replaced to the current Building Regulation Standards.
- Weathering was noted to the rear bedroom doors and doorframe.

Weathering was noted to the rear bedroom doors and doorframe

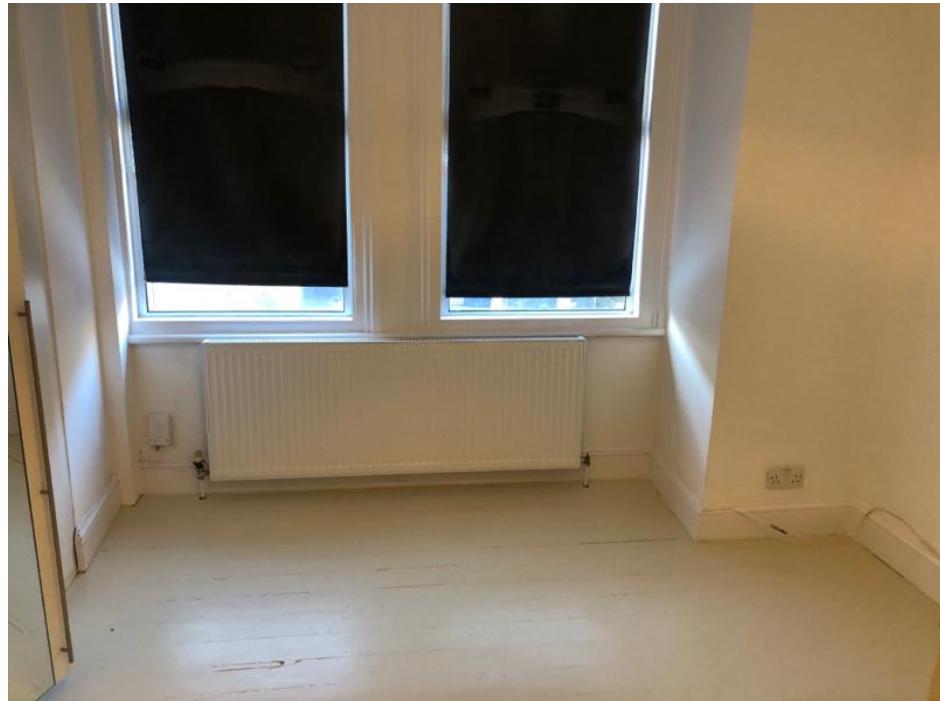
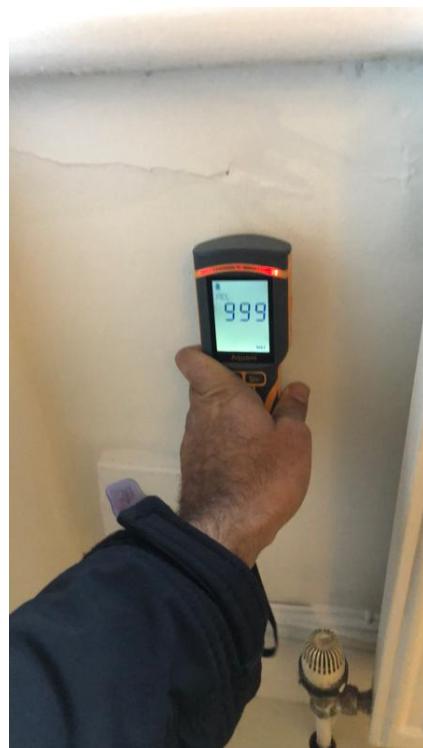
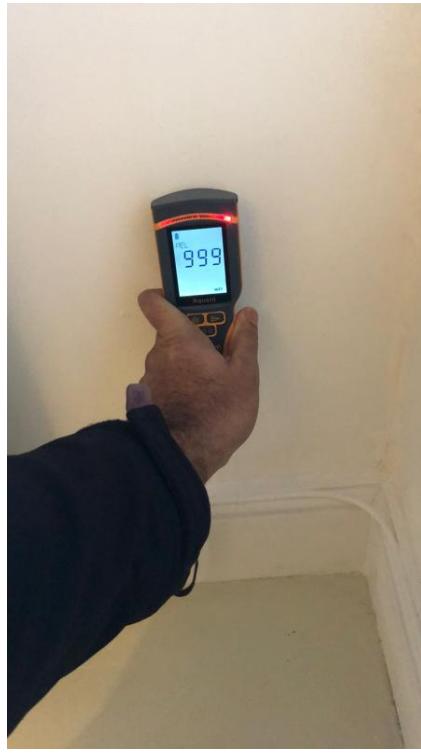
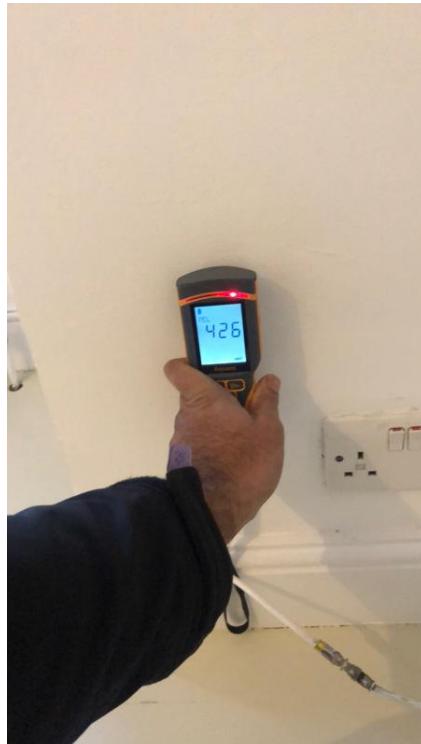
- High moisture meter readings were noted on the wall in the front bedroom. This is likely caused by bridging of any Damp Proof Course (DPC).
- A potentially load-bearing wall has been removed from the ground floor. We are unable to ascertain if the loads from above have been adequately supported, as surface finishes now enclose any support.

High moisture meter readings were noted on the wall in the front bedroom

Walls with high moisture meter readings - You should instruct a specialist contractor to survey the whole property and report to you on the cost of rectification.

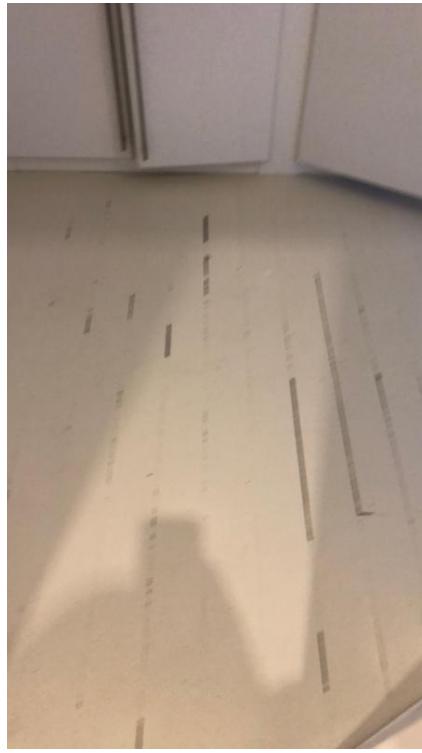
- Gaps were noted between the floorboards throughout the property.

Gaps were noted between the floorboards throughout the property

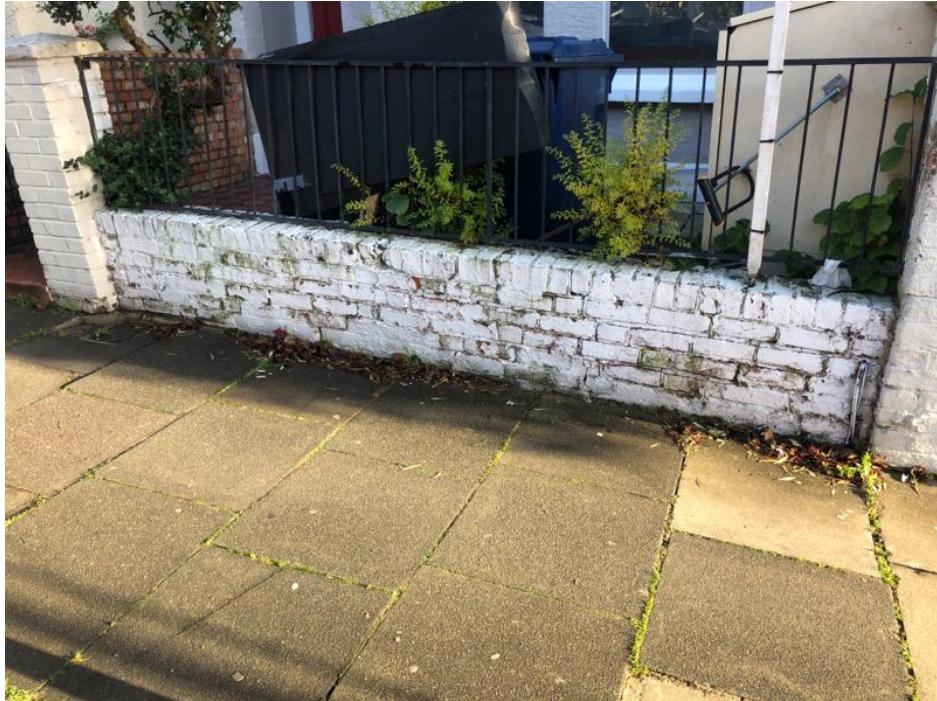
Spalled bricks were noted to the front boundary wall

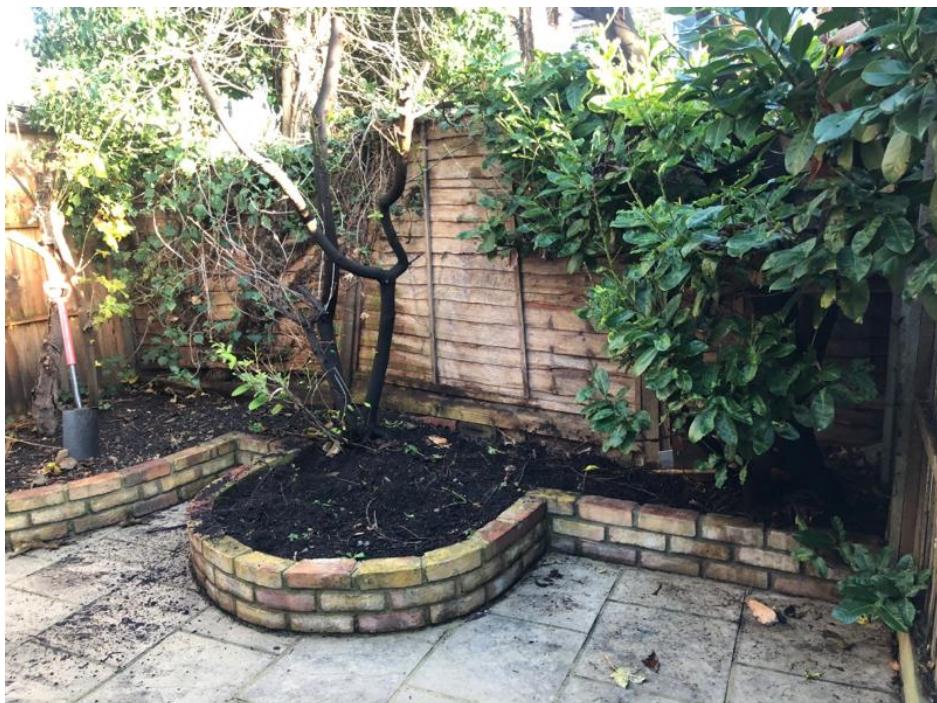
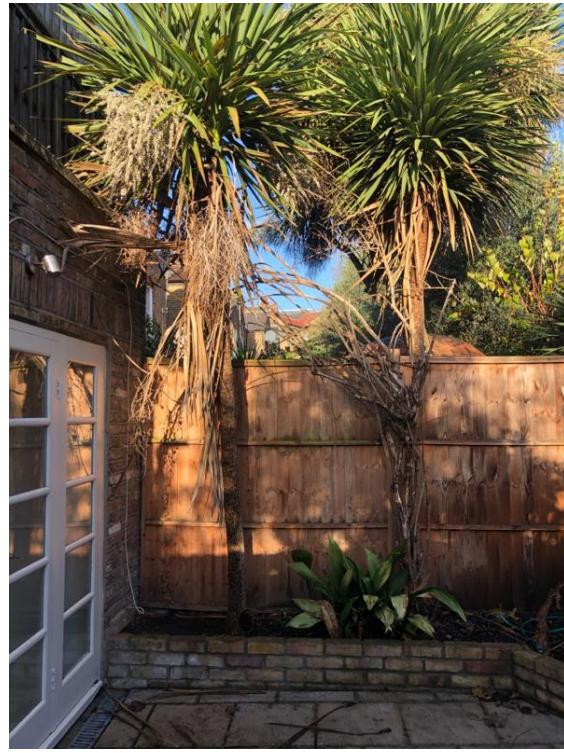
Trees and shrubs were noted in the rear garden
