LEVEL 3

Your survey report...

Surveyor's RICS number
0980814

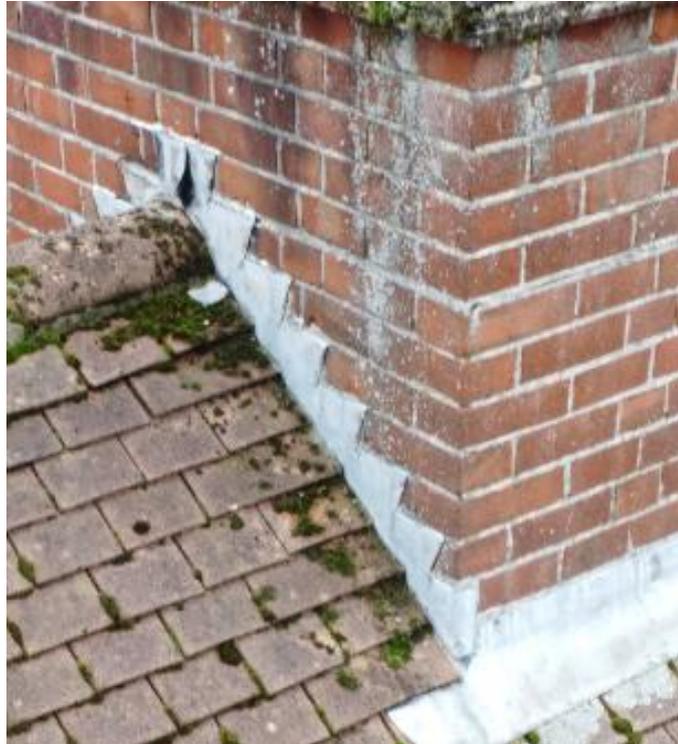
Loose lead flashings were noted to the front chimney stack - This is the likely cause of staining noted on the chimney breast within the roof space (refer to section 'E1 Roof structure')

Loose lead flashings were noted to the front chimney stack

The above defects can allow rainwater ingress, which can cause damage to the roof timbers and structure. Repairs should be undertaken immediately to prevent rainwater ingress.

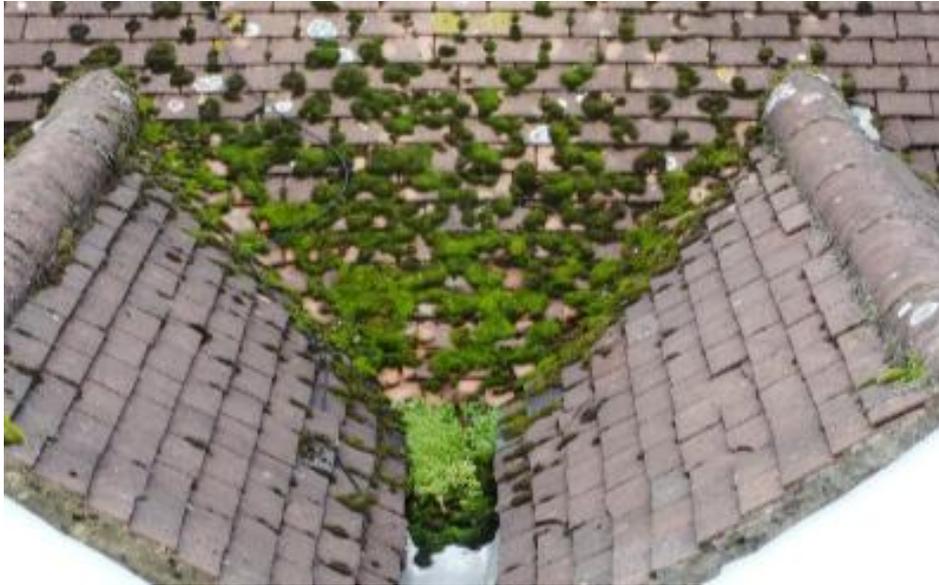
Moss growth was noted in the valley guttering to the main roof.

Moss growth was noted in the valley guttering to the main roof

The above defects can allow rainwater ingress, which can cause damage to the roof timbers and structure. Repairs should be undertaken immediately to prevent rainwater ingress.

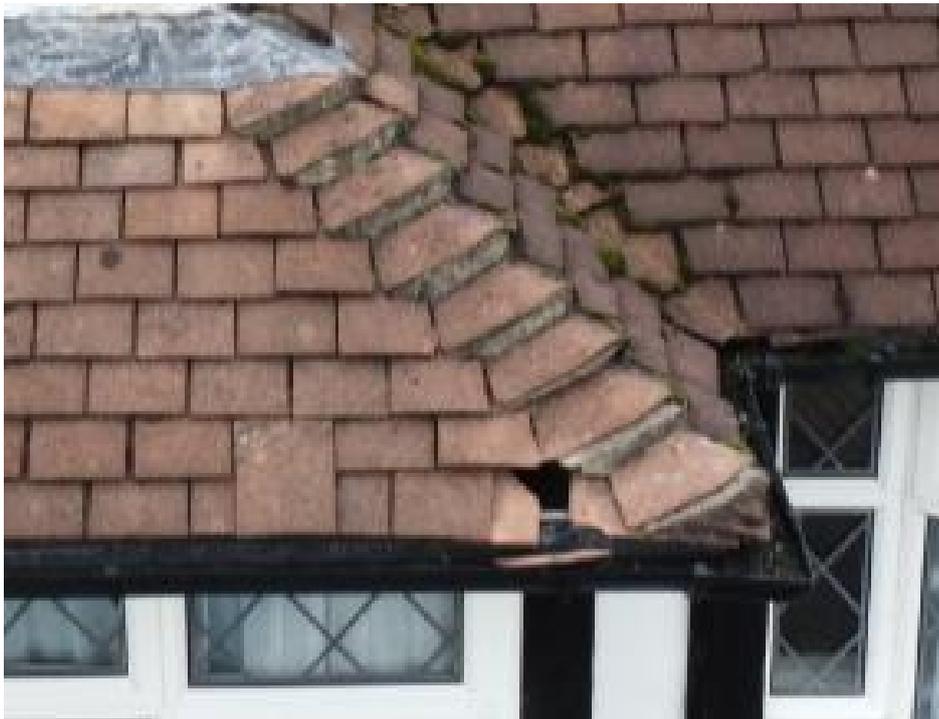
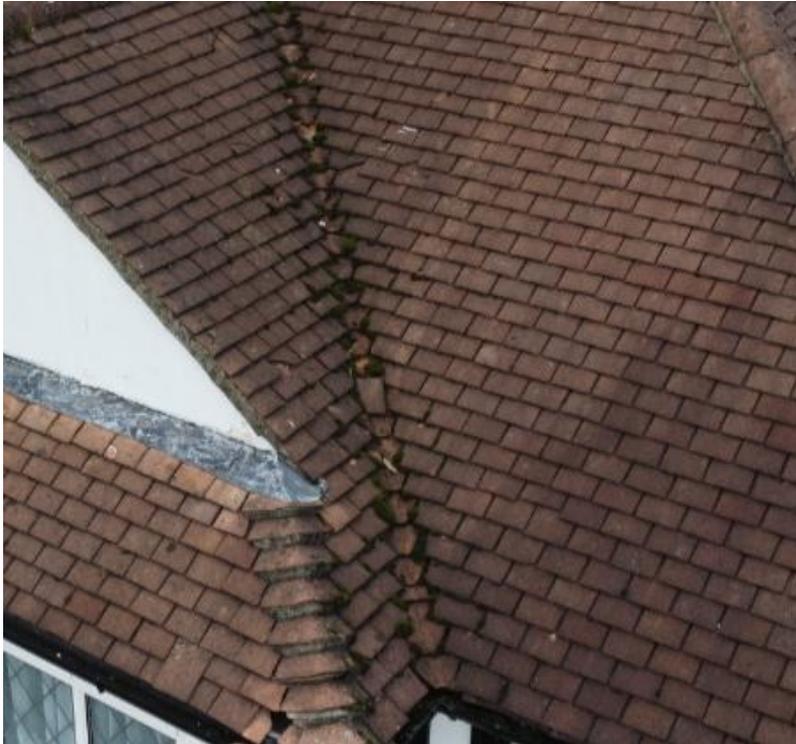
A number of slipped, chipped and cracked tiles were noted to the main roof.

A number of slipped, chipped and cracked tiles were noted to the main roof

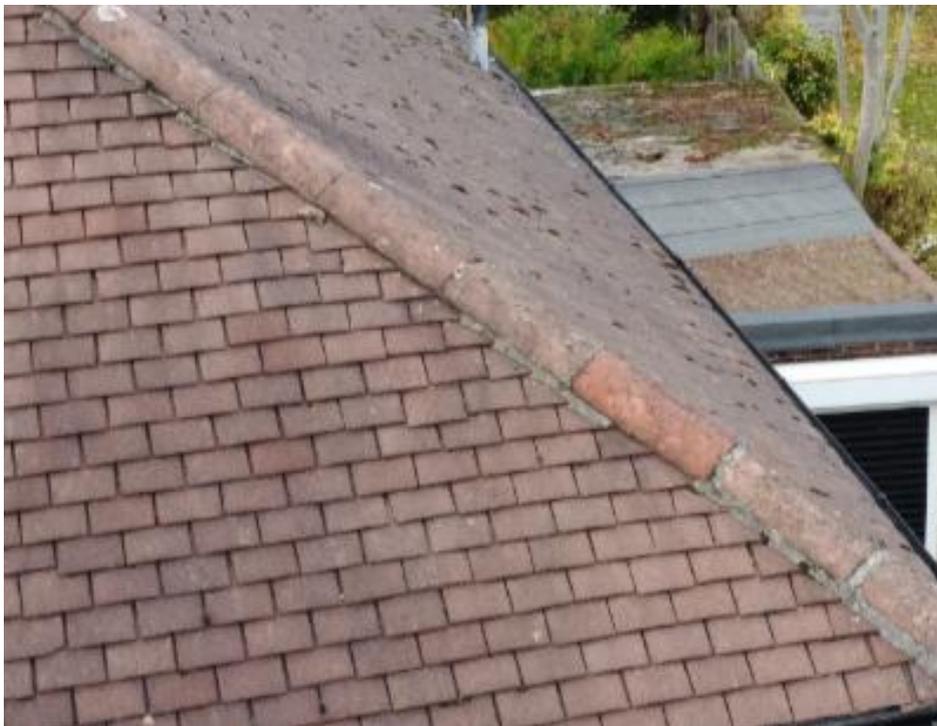
Gaps were noted in the mortar beneath the ridge tiles.

Gaps were noted in the mortar beneath the ridge tiles

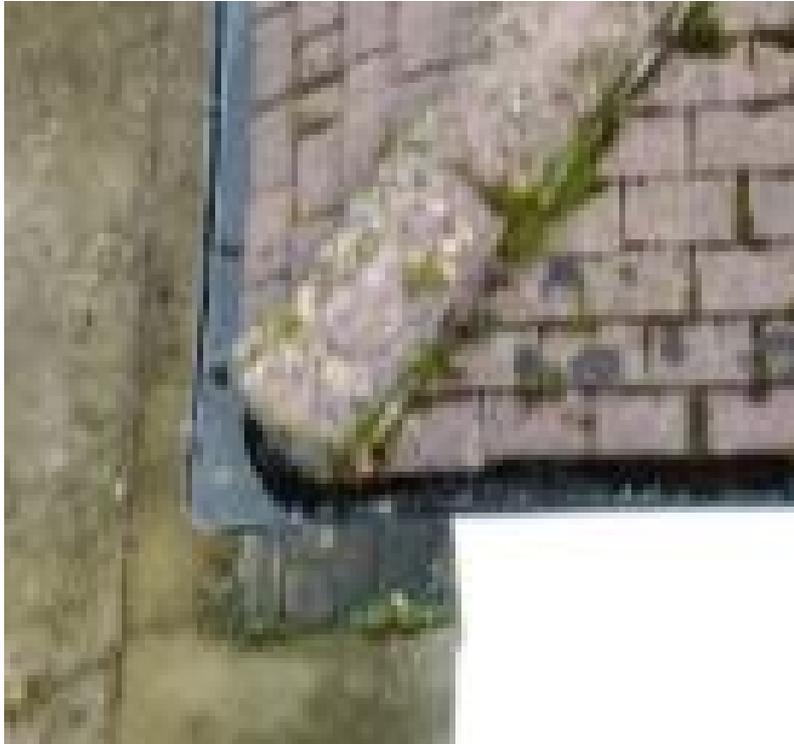
A missing hip iron was noted to the rear elevation of the main roof. Hip irons function as restraints to prevent hip tiles from slipping.

A missing hip iron was noted to the rear elevation of the main roof

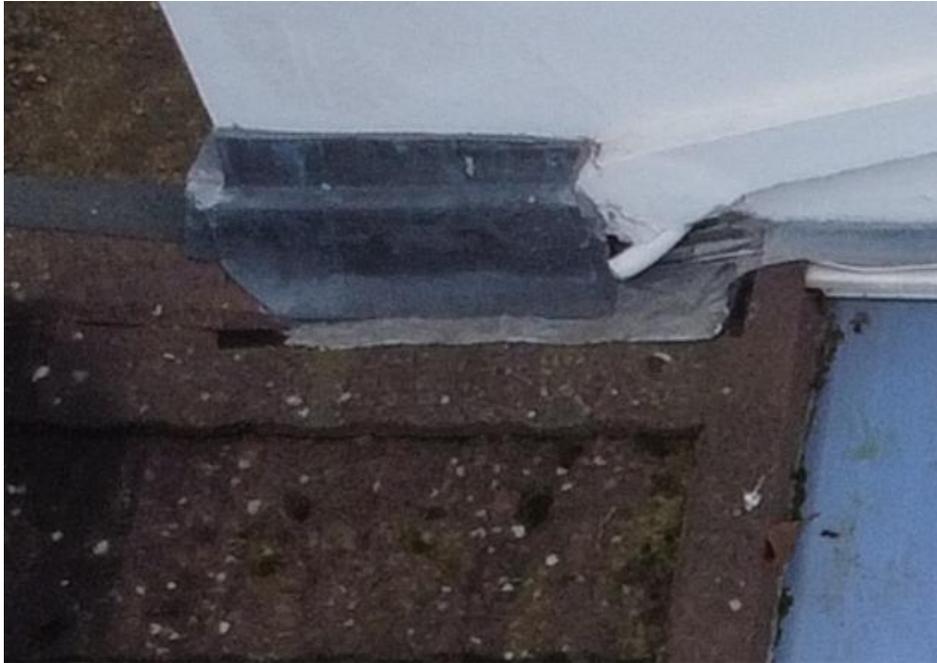
A gap was noted where the side extension roof abuts the main wall.

A gap was noted where the side extension roof abuts the main wall

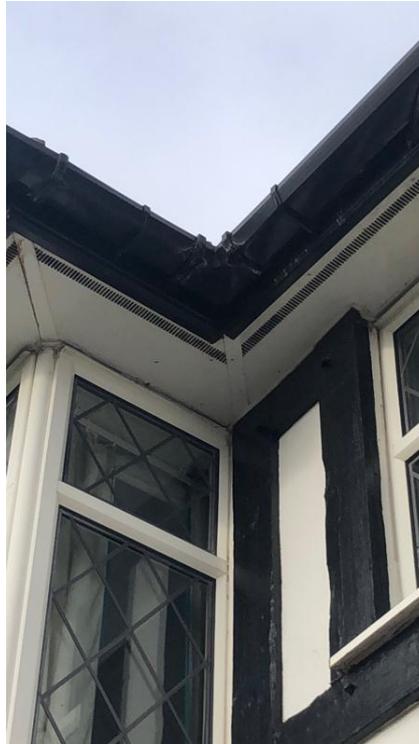
Plastic rainwater fittings experience thermal movements, which can often result in joint leakage developing. Visible algal growth and staining to some joints suggest that this is now occurring;

Staining was noted to the joints of the guttering around the property.

Staining was noted to the joints of the guttering around the property

The above defects should be repaired as soon as possible. Gutters and downpipes need to be checked regularly to ensure that the joints have not come apart. The rainwater pipes should be inspected at least once a year and accumulated leaves, silt and other debris be removed to prevent blockages. During the course of annual maintenance, gutters should be cleaned through to remove any debris such as leaves or moss.

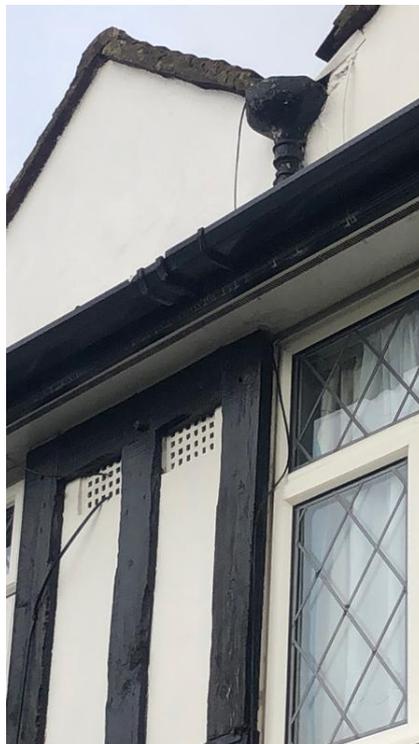
A disconnected guttering joint was noted on the front elevation.

A disconnected guttering joint was noted on the front elevation

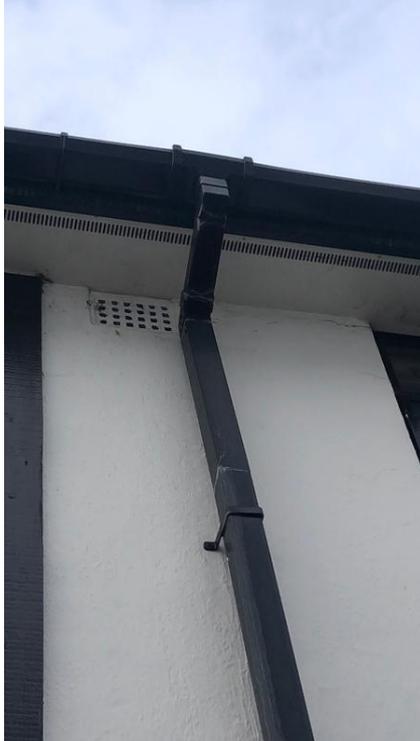
Staining was noted to the joints of the downpipes around the property.

Staining was noted to the joints of the downpipes around the property

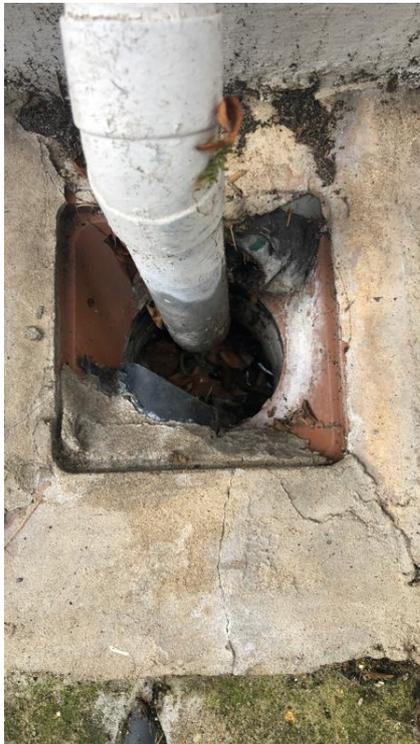
Foliage was noted in the gully to the side of the property.

Foliage was noted in the gully to the side of the property

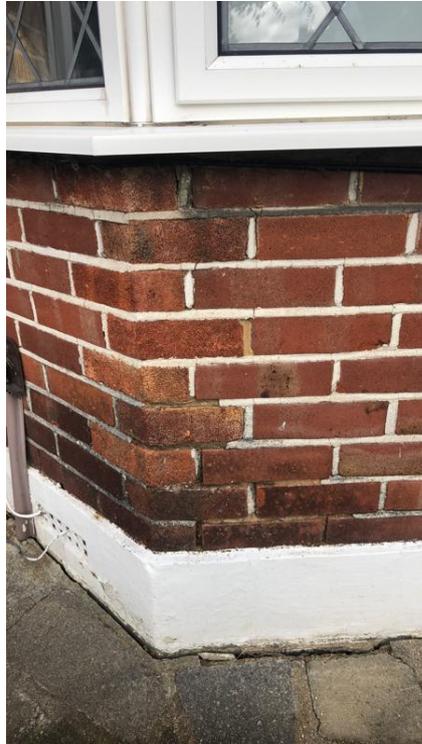
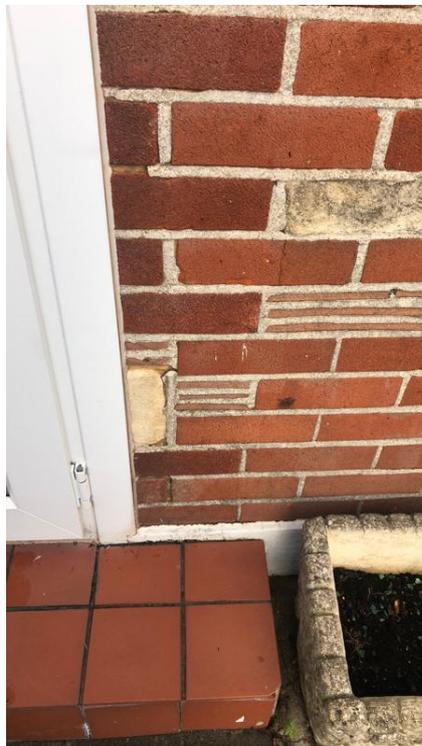
Gaps were noted in the mortar pointing around the property.

Gaps were noted in the mortar pointing around the property

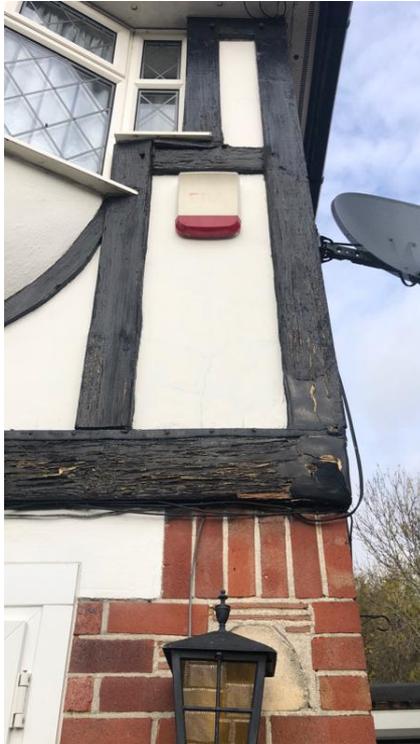
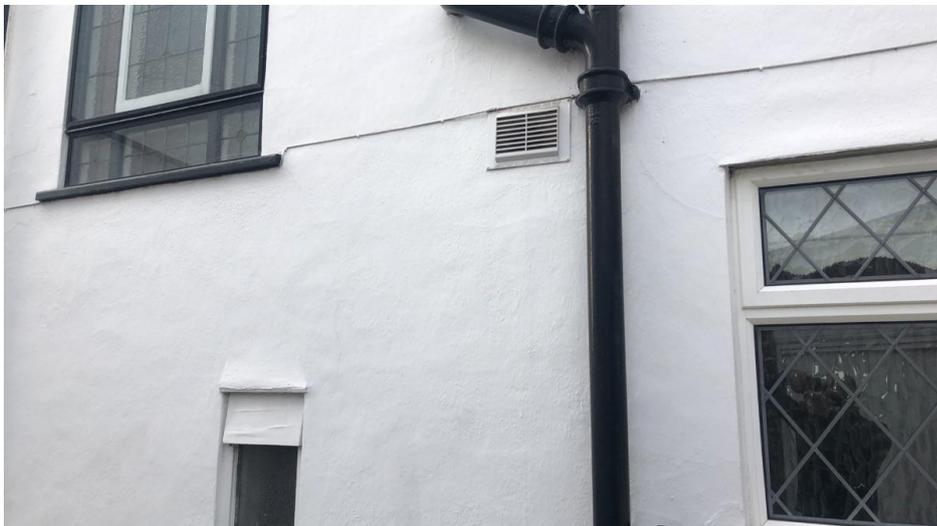
Shrinkage cracks were noted to the render finish around the property. This is due to shrinkage and loss of adhesion over time. We could not examine closely any higher areas.

Shrinkage cracks were noted to the render finish around the property

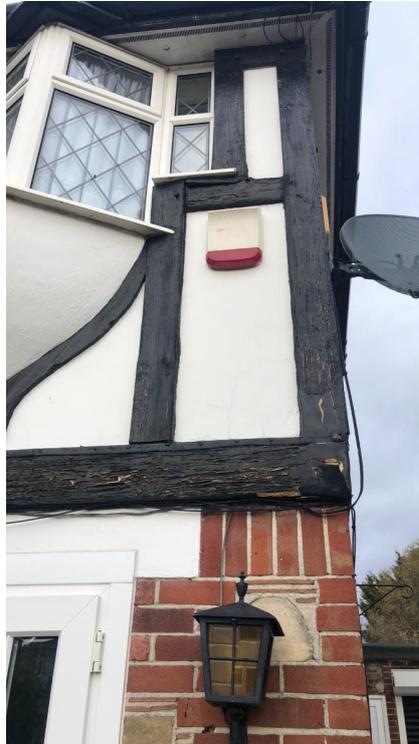
Rot was noted to the mock-Tudor timber decorations around the property.

Rot was noted to the mock-Tudor timber decorations around the property

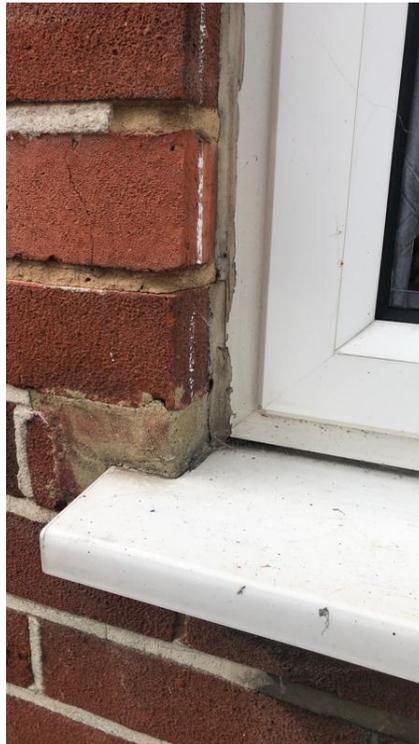
Deterioration was noted to the sealant around some window frames

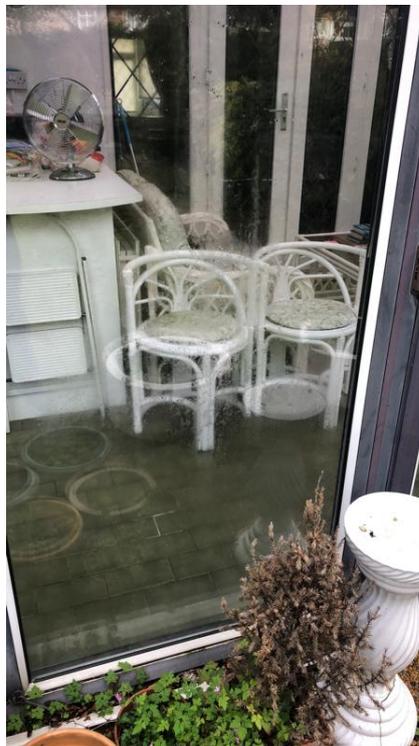
Misting was noted to the conservatory windows

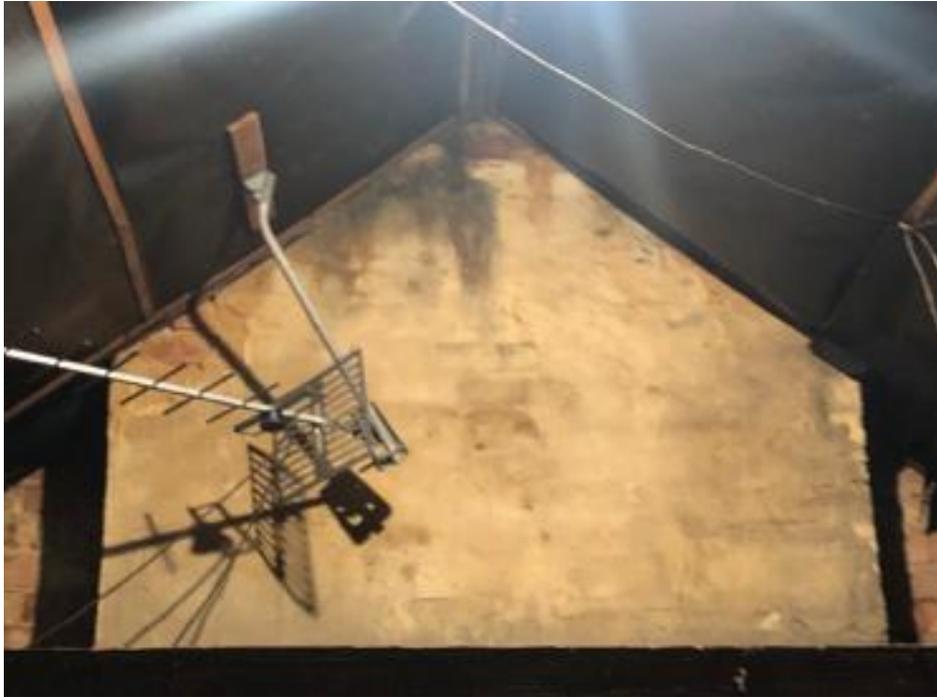
Staining was noted to the chimney breast in the roof space

Once the chimney stack has been repaired, the staining can be repaired as required.

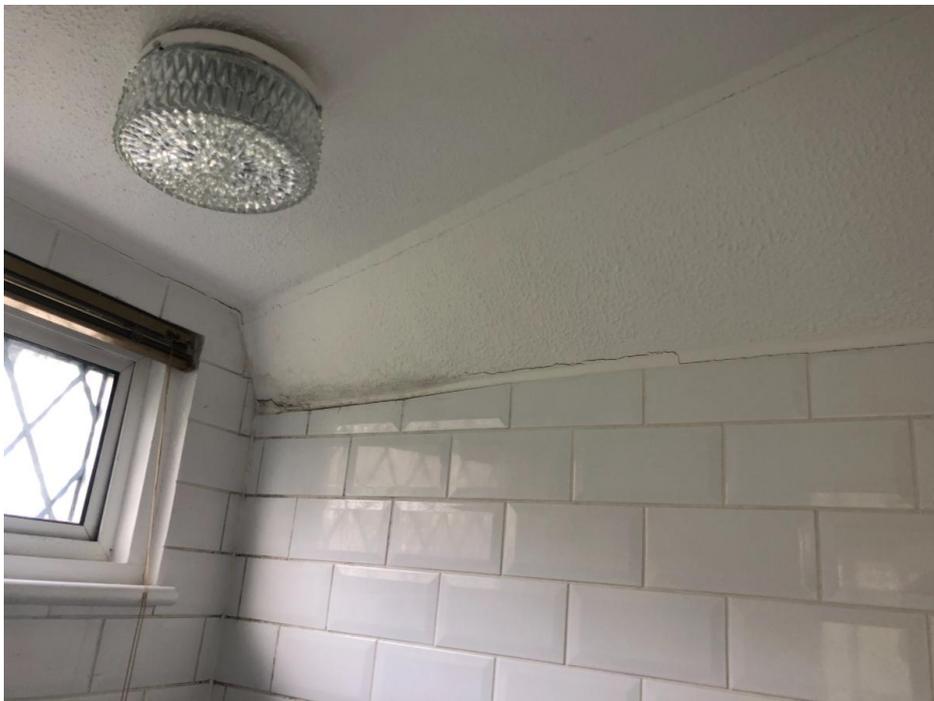
Hairline cracking was noted to the ceiling in the downstairs WC.

Normal maintenance, including filling and redecorating hairline cracks, is required to the ceilings

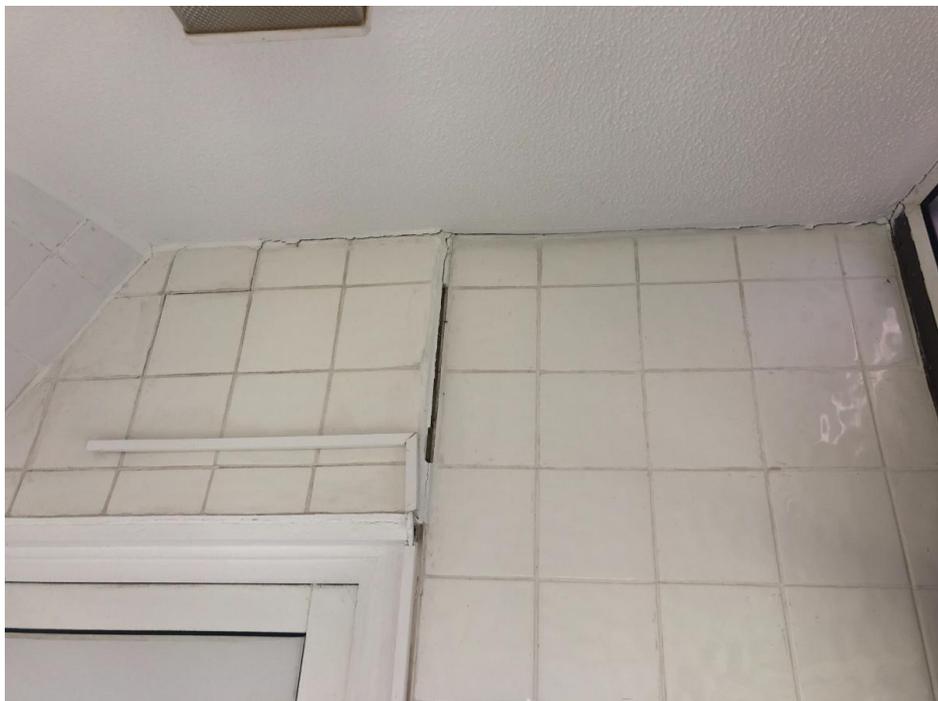
Settlement cracks were noted to the wall in the utility room. This is likely caused by differential settlement of the foundations to the side extension, causing some movement to the walls. The extent of movement could not be fully observed due to the walls being covered with tiles.

Settlement cracks were noted to the wall in the utility room

The above defect should be repaired and monitored moving forward. If continued progressive movement is observed, then a structural engineer should be commissioned to ascertain the extent of any remedial works required.

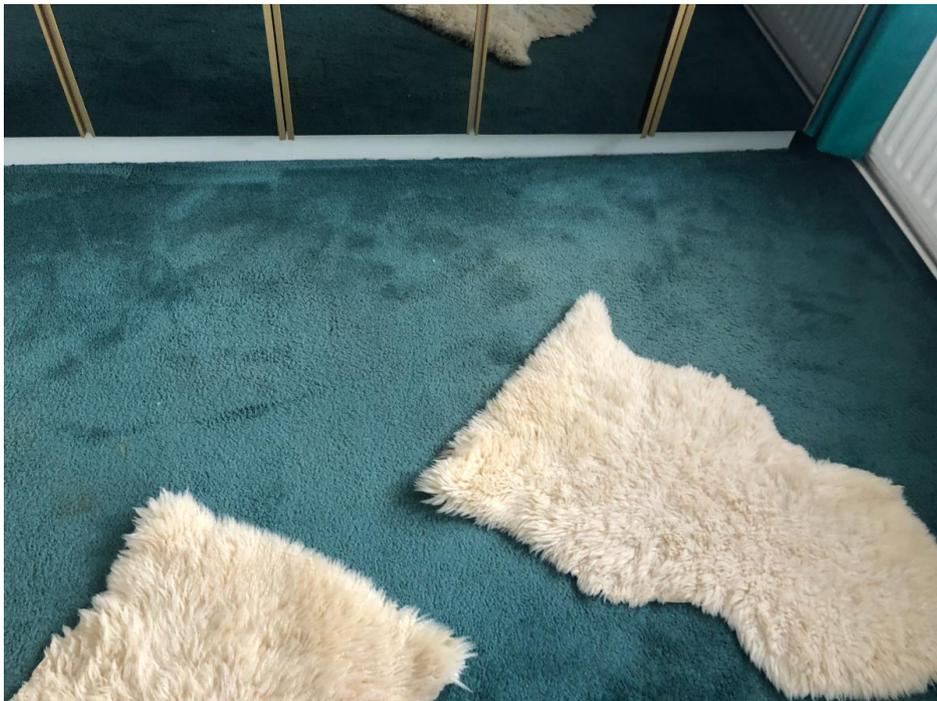
Loose floorboards were noted in the master bedroom. Floorboards can become loose naturally over time as floor joists and timbers settle.

Loose floorboards were noted in the master bedroom

The floor covering should be removed and the floorboards inspected for possible defects. Any defects identified should be repaired as required.

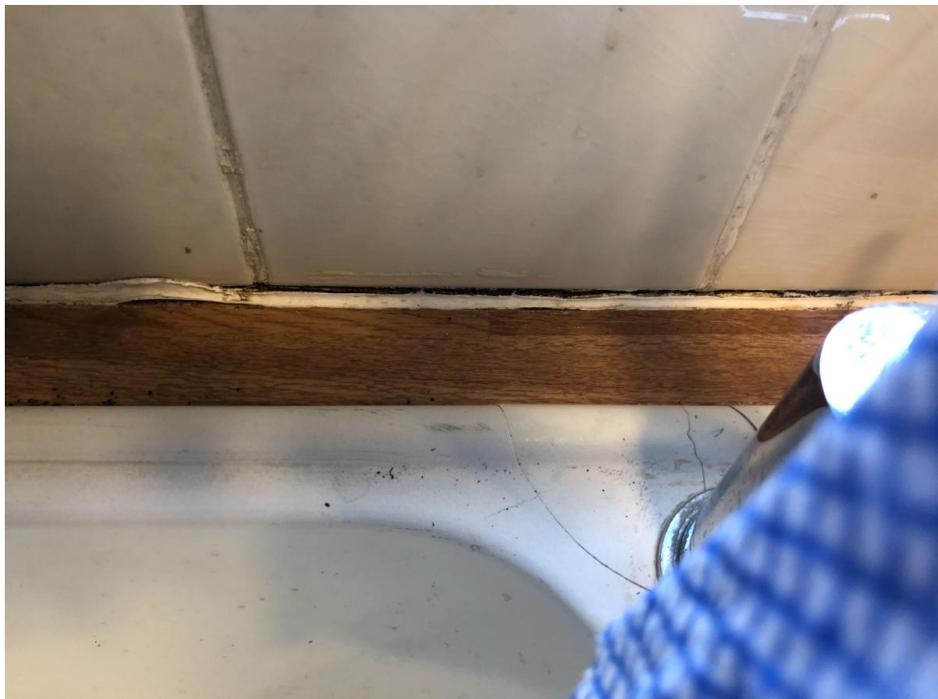
The flexible sealants around the worktop and fittings is in poor condition

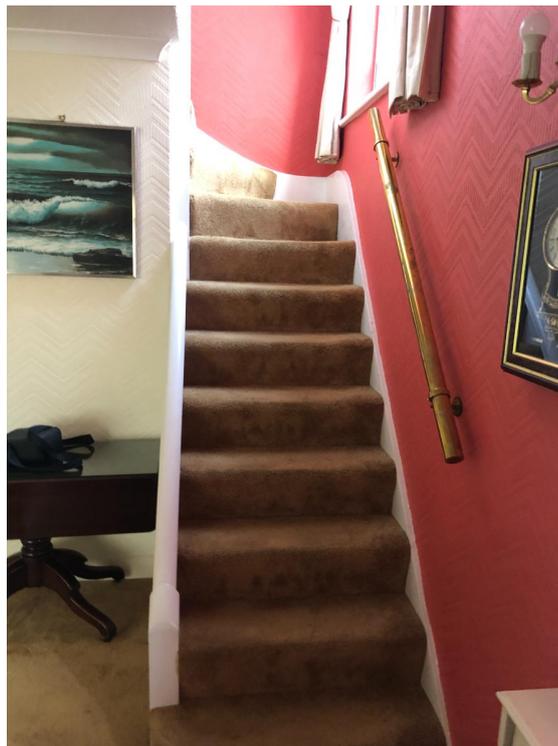
The balustrade and handrail have been removed on the lower part of the stairs

Install a balustrade and handrail to the stairs to prevent accidents from occurring.

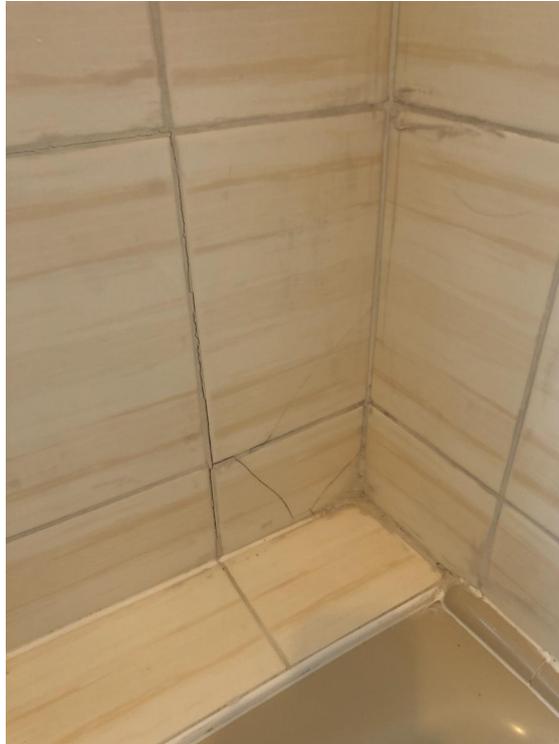
Cracked wall tiles were noted in the bathroom

Repair the cracked walls tiles as soon as possible.

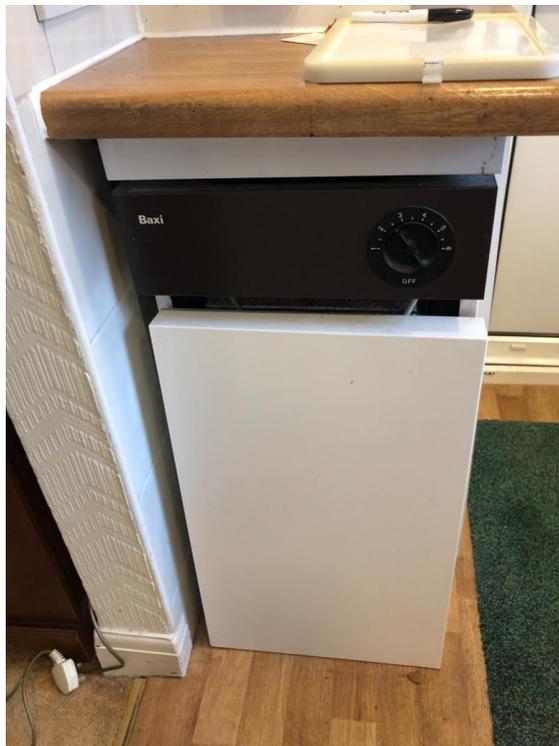
Boiler

The system is dated and has reached the end of life for serviceability. You should ask a Gas Safe Heating Engineer to provide a quotation for complete replacement and updating.

Old radiators will fail progressively and they will require to be replaced.

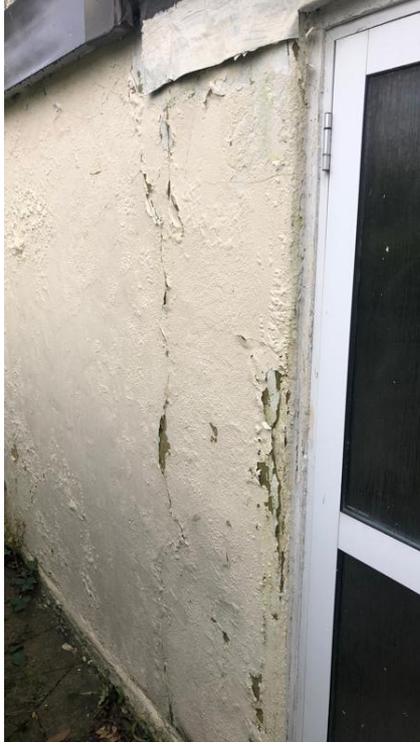
Blistering render was noted to the exterior garage walls.

The above defects should be repaired as soon as possible.

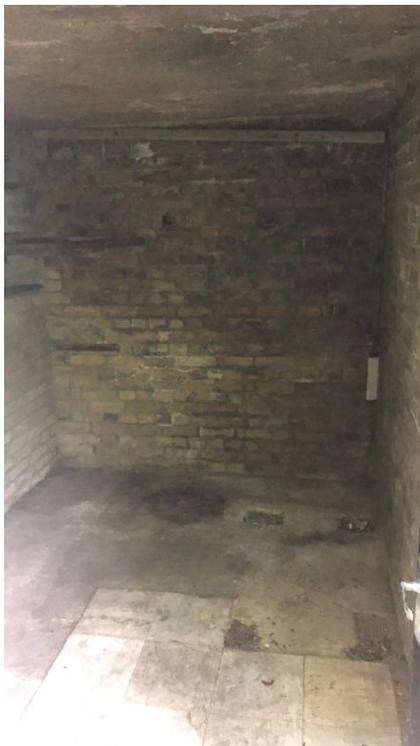
Damp was noted to the internal garage walls.

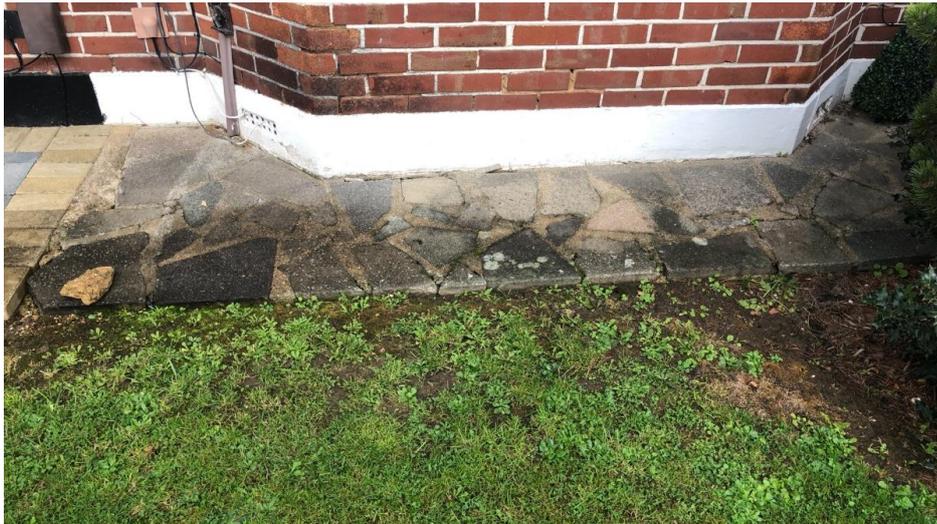
Settlement was noted to the grounds at the front of the property

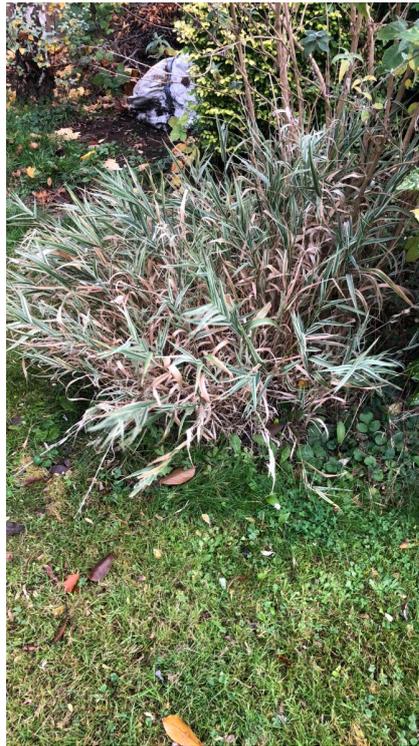
Bamboo plants were noted in the rear garden
