LEVEL 2

Your survey report...

Surveyor's RICS number
0980814

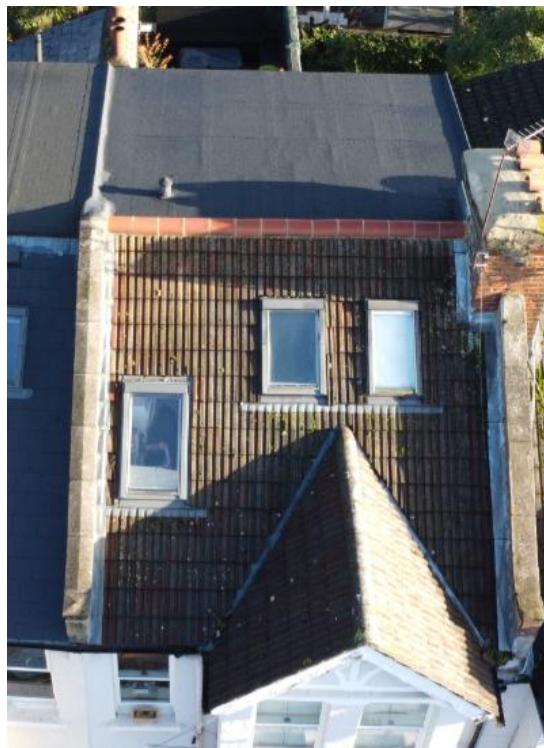
Main roof front elevation

When opting for a heavier tile roof covering, the added weight increases the load on the roof structure. This type of work must receive approval from the Local Authority Building Regulations department. Prior to purchase, it is essential for your legal advisors to verify that this certification has been issued.

Flat roofs are susceptible to sudden leakage, especially at the joints/seals. Although no such defects were noted at the time of inspection.

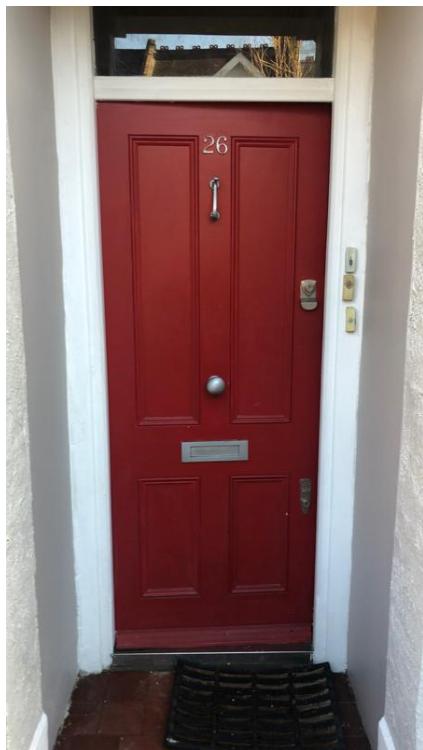
Timber communal front door

You should be aware that previous owners may have distributed multiple sets of keys for the external doors to individuals not known to you.

When purchasing a property, consider the cost of replacing all external door locks as soon as possible after taking occupation. When doing this, consult your insurers to ensure the keys meet their security requirements.

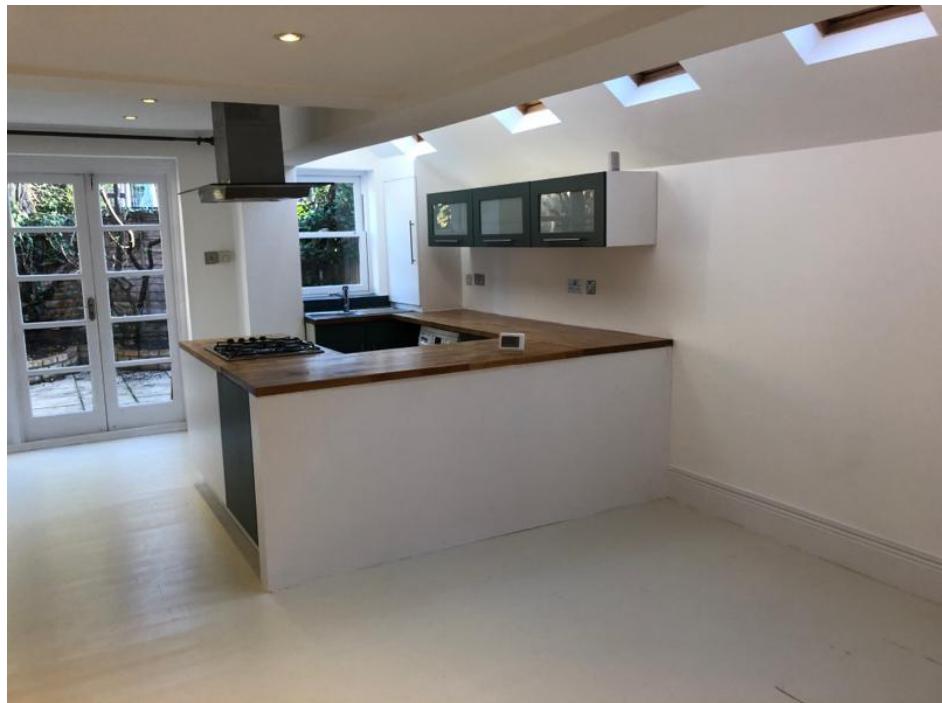
Kitchen

The cooker hood extractor fan should be kept operational when cooking to reduce condensation.

Sealants around sinks and fittings should be periodically renewed to prevent water penetration from damaging the cabinets and causing rot in unseen areas behind the units.
