LEVEL 3

Your survey report...

Surveyor's RICS number
0980814

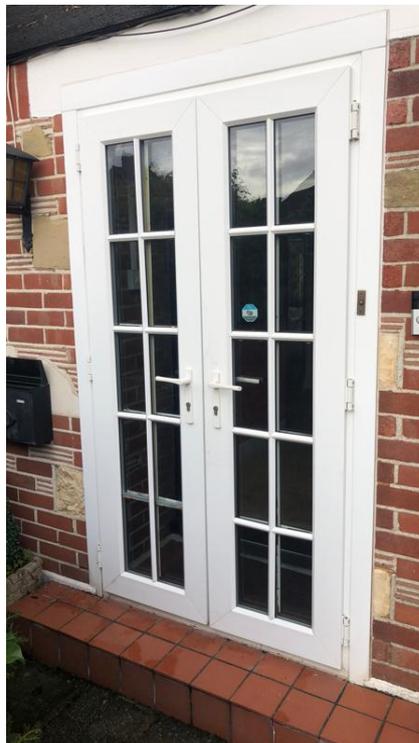
Porch doors

We could not find any British Standard Safety Marks to the glazed elements and we assume that the glass is not "Safety Glass". We recommend that the glass is replaced to current Building Regulation Standards.

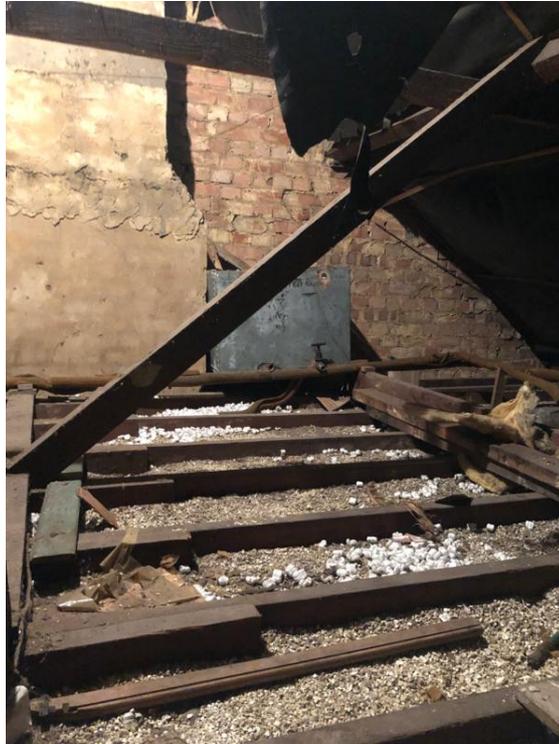
Disused cold water tanks were noted in the roof space

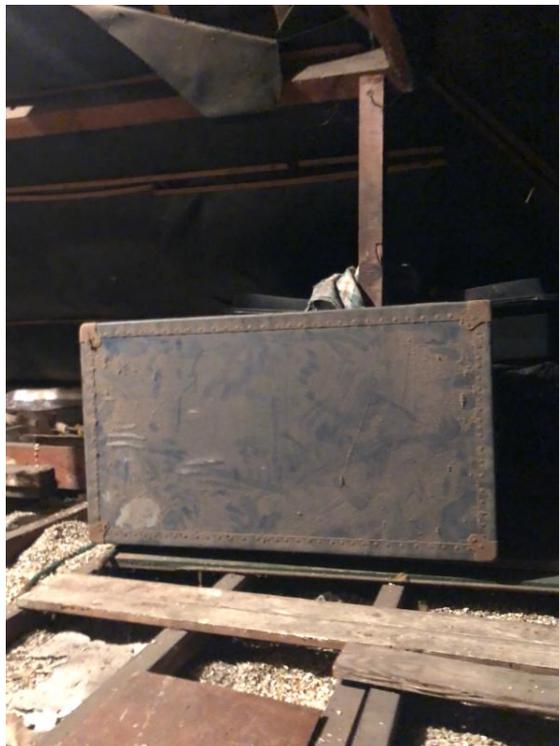
Stored possessions were noted in the roof space

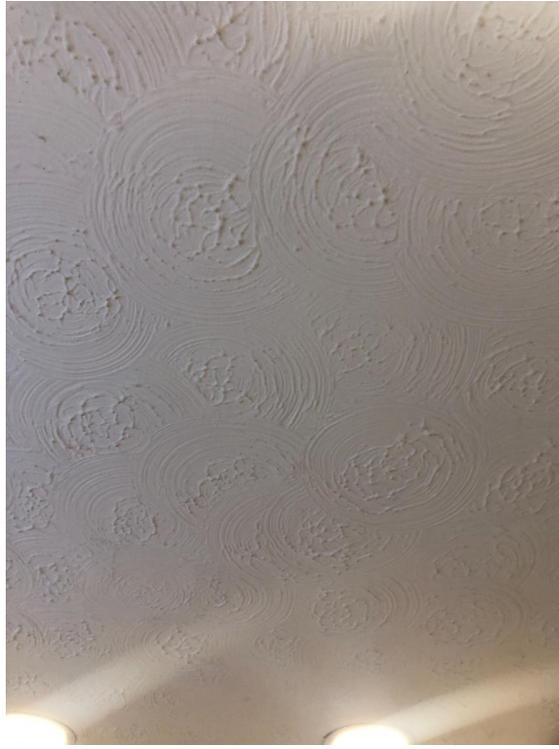
Example of an Artex ceiling finish

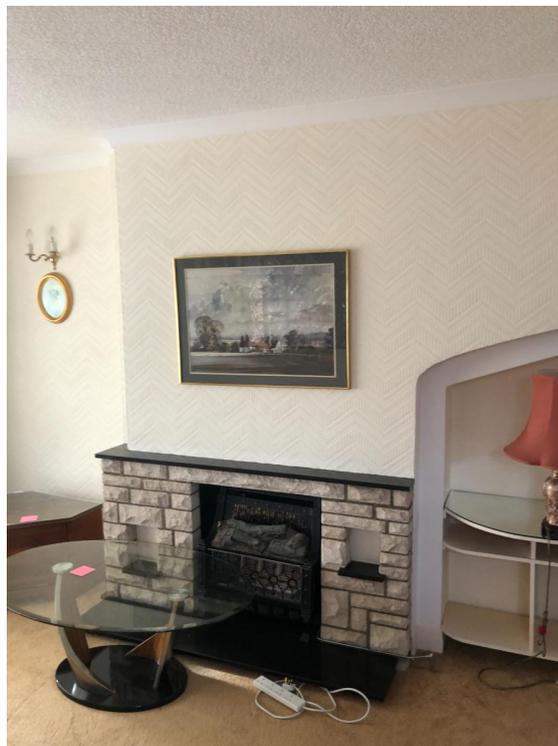
Chimney breast in the front reception room

The chimney breasts appear sound. However, it was not possible to inspect the flues in detail. We would advise you to have any gas fires examined and tested by a Registered Gas Safe engineer before use and to confirm there is adequate ventilation to the appliance.

If any fireplace is to be used, the flues should be swept and any flue lining checked before use. You should obtain advice from a chimney sweep or a HETAS Registered contractor.

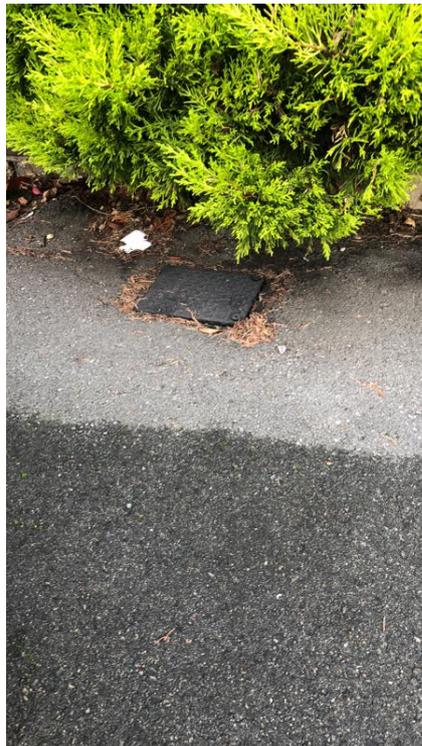
Stopcock

There is no water storage facility in the property. Should the mains water supply fail you may have no water supply.

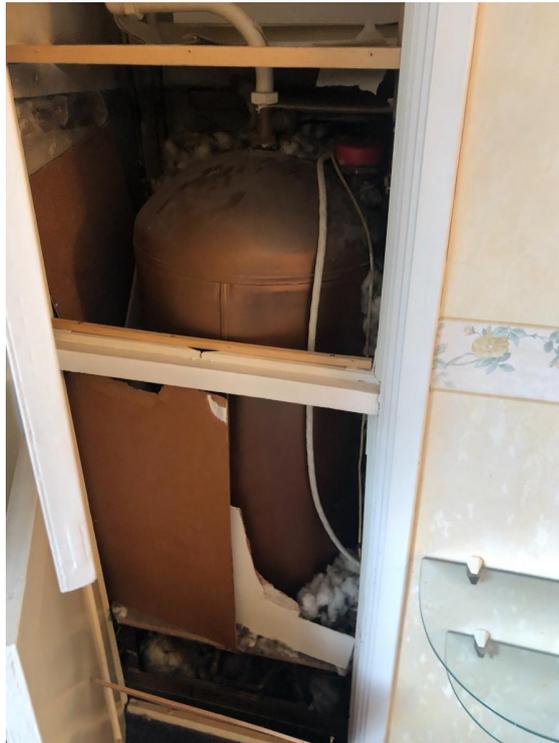
Hot water immersion tank

Hot water is provided by the main heating boiler and stored in a hot water cylinder. Please see our comments in F4 above. You should arrange for a competent contractor to inspect and test the system and recommend any required repairs or improvements.

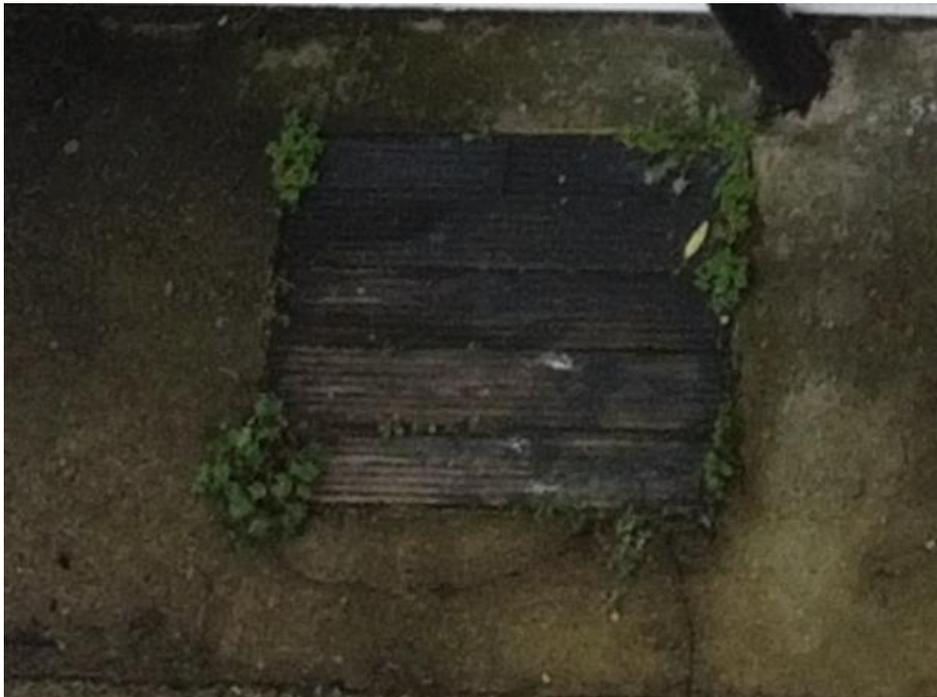
Some of the drains appear to run under the rear extension and this will make repair more difficult, possibly very disruptive and expensive.

Drainage cover inaccessible

Gullies will require regular cleaning. The drains should be regularly flushed through.

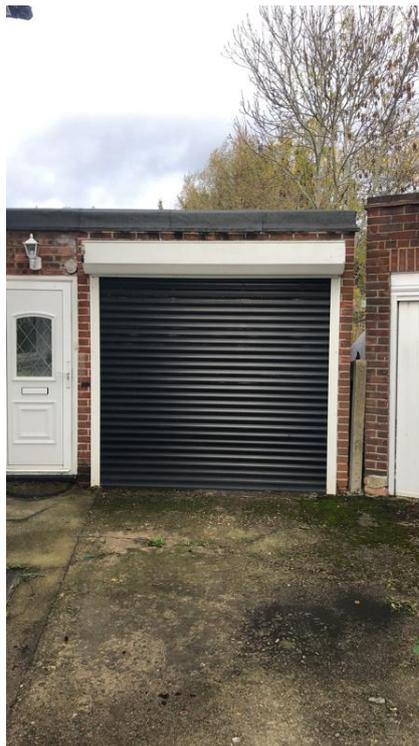
Garage

The garage is in a serviceable condition.

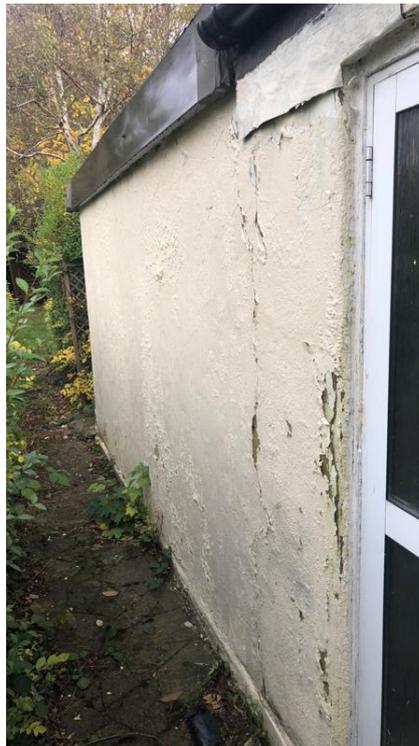
Outbuilding

The outbuilding should not be used for human habitation in its current guise.

The above defects should be repaired as soon as possible.

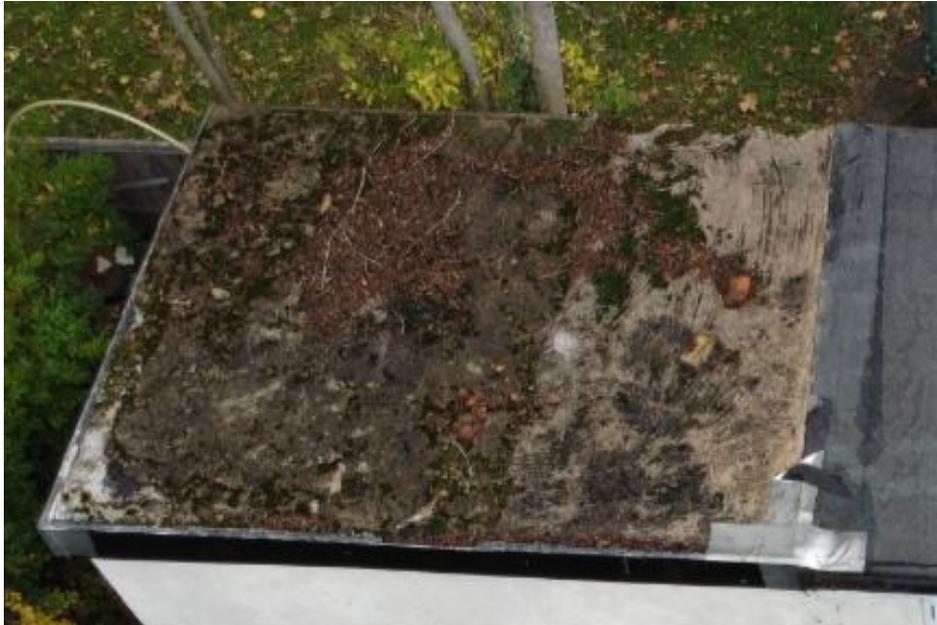
Outbuilding roof

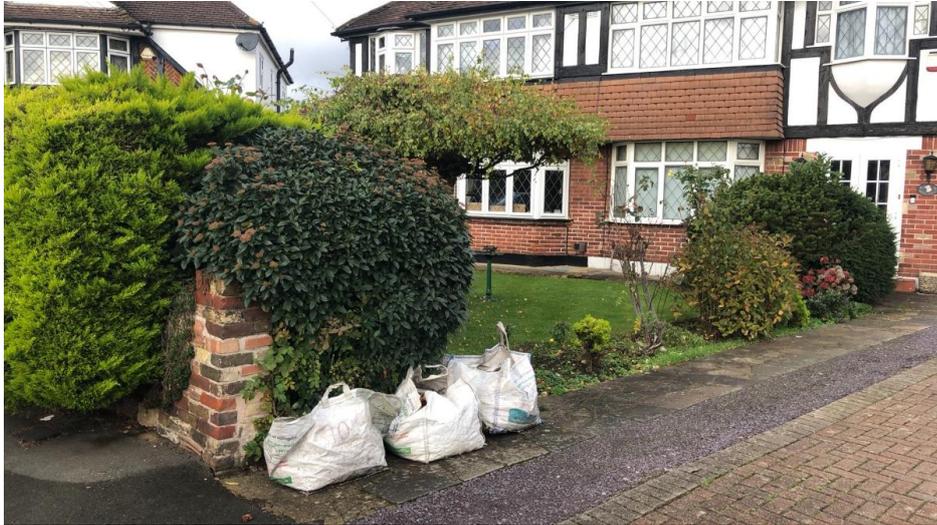
There are trees and shrubs in the front and rear gardens. Trees and shrubs can cause damage to buildings and services but no signs of such damage were seen. Tree roots extract moisture, causing shrinkage in the subsoil on which the foundations are bearing, particularly during drought conditions when shrinkage of the subsoil can cause subsidence of the foundations. Conversely, when trees are removed swelling of the subsoil can occur causing 'heave' resulting in upward movement of foundations. Arrangements should be made for the trees to be kept regularly pruned to prevent them from increasing in size and causing damage to the property walls and foundations.

There are trees and shrubs in the front and rear gardens

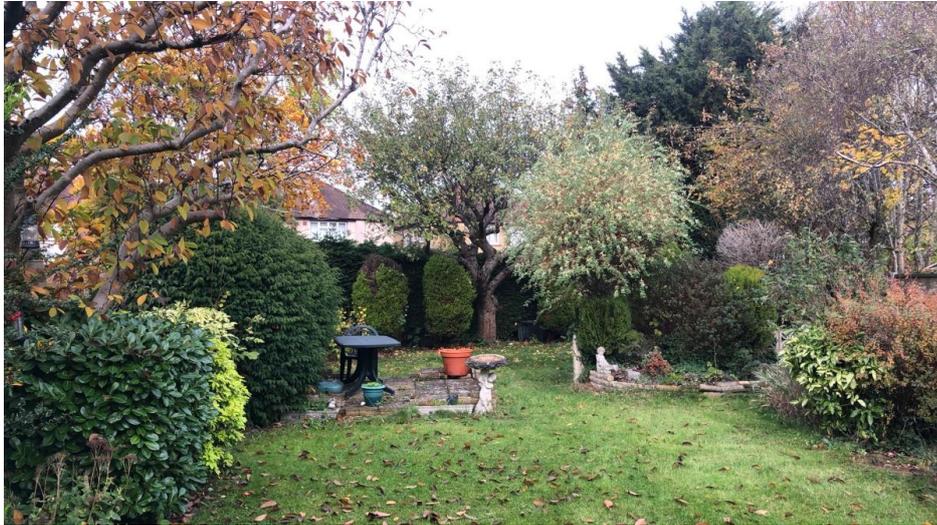
There are trees and shrubs in the front and rear gardens

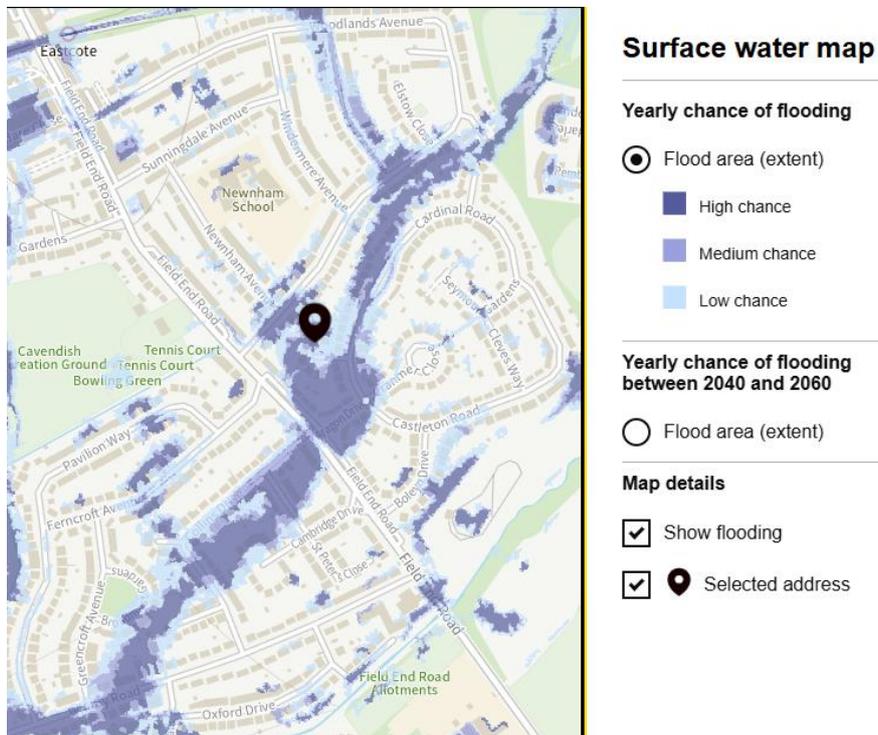
Flood risk map

The property is in an area that is at high risk of surface water flooding.
